# Analyzing Moisture Problems In Concrete Slabs

*Use these case histories to learn from others' design and construction mistakes*

BY JOHN A. AMUNDSON, BRIAN J. PASHINA, AND TERRANCE E. SWOR

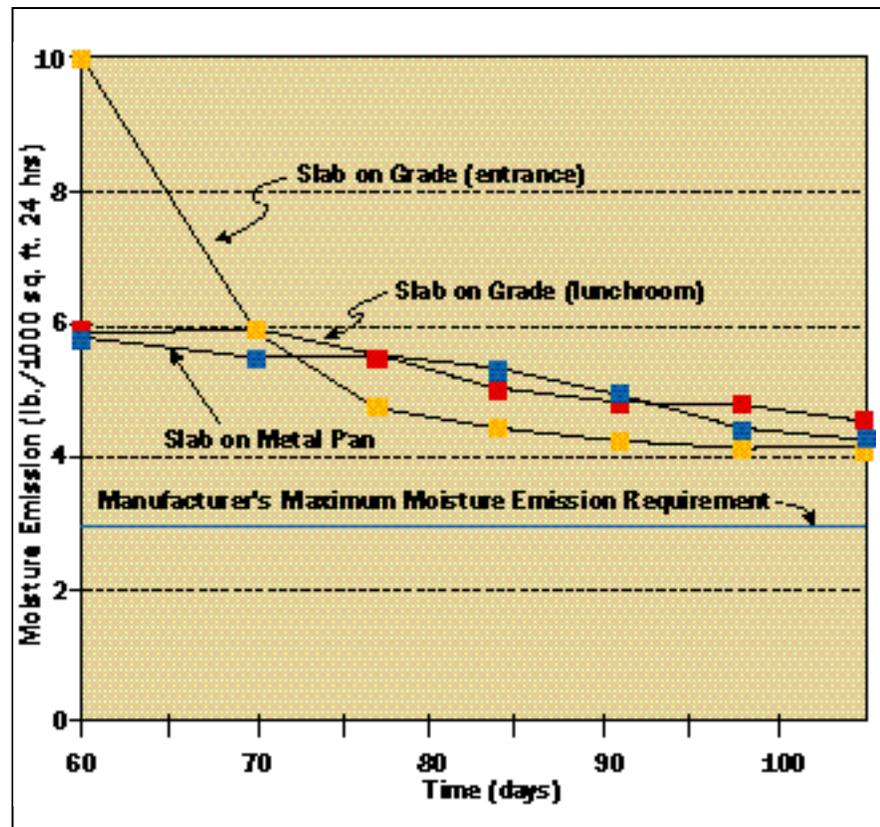
Figure 1. Variations in moisture emission over time for concrete slabs of differing thickness and cast on differing surfaces.

Testing revealed a gradual decrease in the moisture-emission rate over the 15-week monitoring period. At the end of 15 weeks, however, the moisture-emission rate still remained above the 3 pounds per 1,000 square feet per 24 hours maximum value required by the flooring manufacturer. (Refer to Figure 1 for the complete test results.)

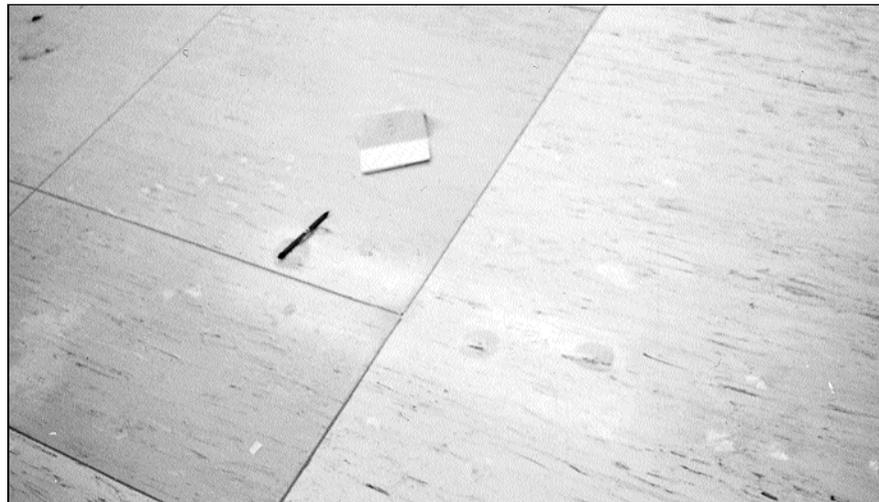
Figure 2. Blisters in seamless vinyl flooring are commonly caused by moisture emissions in concrete floors. Most blisters in this hospital surgical suite ranged from 1 inch to 4 inches in diameter.

On several large projects, the behavior of flooring materials indicates that the forces exerted by water-vapor transmission can be quite large. One such project was a hospital surgical suite. It received an application of  $\frac{3}{16}$ -inch-thick seamless vinyl flooring bonded to a concrete slab on grade with an epoxy adhesive provided by the flooring manufacturer. The bond was so tenacious that it was virtually impossible to pry the flooring from the slab after numerous blisters developed in the flooring and required investigation. The blisters appeared about one year after construction, and they grew larger over time (Figure 2). The blisters ranged from  $\frac{1}{4}$  inch to 15 inches in diameter and were as much as  $\frac{3}{4}$  inch high, creating a tripping hazard for the facility's surgeons and

The floor slab was placed on cohesive soils without a vapor barrier or sand cushion. Soil borings indicated the water table was 8 to 13 feet below grade and that the site soils were moist, cohesive materials with a moisture content ranging from 7% to 32.4%. RMA test kits indicated emissions ranging from 7 to 13 pounds per 1,000 square feet in 24 hours.

Core samples revealed that the  $\frac{3}{16}$ -inch-thick vinyl flooring was permanently deformed at the blisters. The coring also revealed bond failure of the epoxy adhesive at the blisters, though the flooring was firmly bonded to the area around the blisters and could not be pried from the slab.

epoxy adhesive were unaffected by water-vapor pressure. But the fact that the blisters continued to grow indicated that vapor pressures were large enough to permanently deform the flooring and exceed the epoxy-adhesive bond to the concrete and tile. The culprits: the surgical suite's air-conditioning units and the subgrade soils' high moisture contents. The vapor pressure differential was large enough to develop the high pressures that led to deformation of the floor covering.

A review of the flooring manufacturer's literature revealed that a below-grade vapor barrier with a sand cushion was required on all slab-on-grade installations. On this project, a sand cushion was specified, but not a vapor barrier. Had both been installed, the risk of failure on this project could have been greatly minimized.

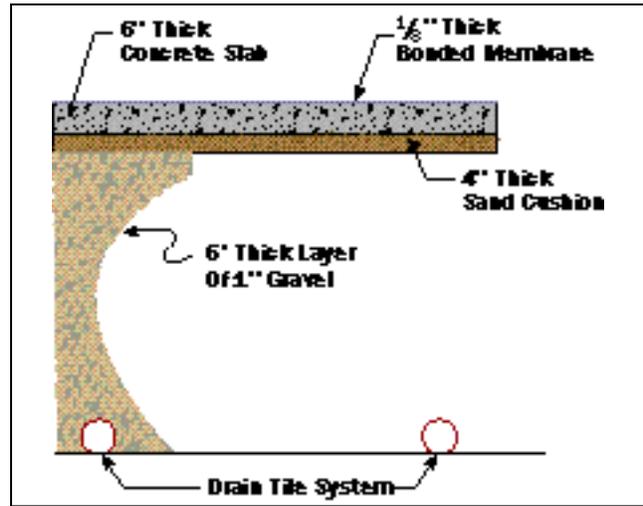
Figure 4. Swimming pool floor construction details.

As Figure 4 indicates, the pool floor construction consisted of a 6-inch-thick reinforced-concrete slab on grade, a 4-inch-thick sand cushion, and a single-size 1-inch-diameter rounded-gravel layer to a depth 6 feet below the pool slab. Drain tile was present at the bottom of the gravel layer.

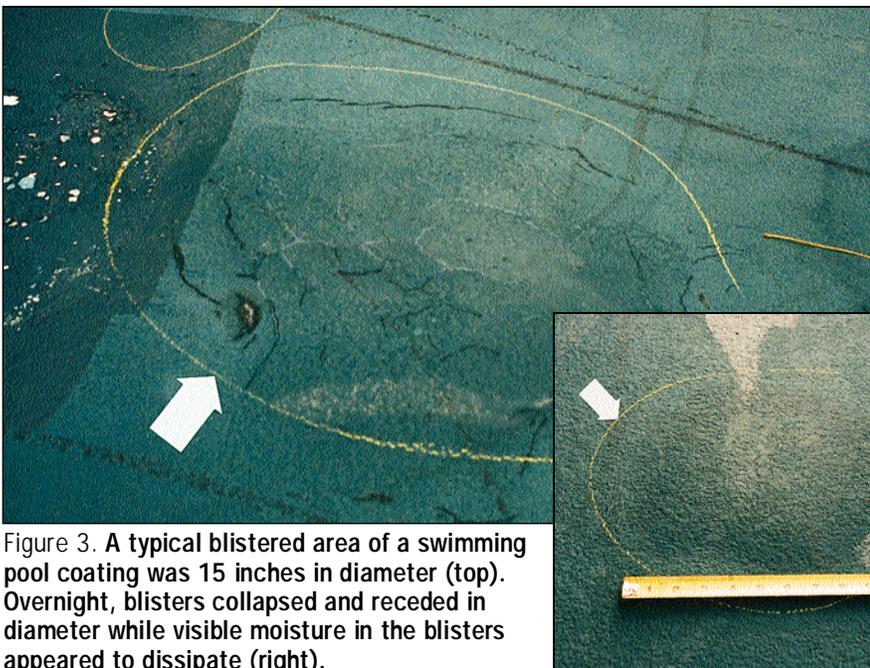
Figure 3. A typical blistered area of a swimming pool coating was 15 inches in diameter (top). Overnight, blisters collapsed and receded in diameter while visible moisture in the blisters appeared to dissipate (right).

pool for routine cleaning and maintenance, the owner noticed that the pool's bonded membrane blistered on sunny days. Moisture bled from the blisters during the day; overnight, the blisters collapsed and visible moisture in the blisters appeared to dissipate (Figure 3). When the pool was empty, the blistering gradually increased, but did not appear to worsen when the pool was filled with water.

Moisture emissions through the slab were measured with RMA moisture kits, and cores were drilled to observe the moisture condition of the soils below the slab. Emission rates ranging from 15 to 30 pounds per 1,000 square feet per 24 hours were documented. Normally, the test duration is 60 to 72 hours, but on this project testing was performed over 24 hours due to the large amount of moisture accumulating in the

desiccant. During the day the desiccant would nearly dissolve, indicating very high moisture emission from the slab. Overnight, however, this same desiccant would lose moisture and become semidry. Coring revealed that the 4-inch-thick sand layer and the gravel layer below the slab were only slightly damp. When the gravel was removed from the core hole, the gravel surface quickly dried.

Even though no free water was present in the subgrade, large amounts of water vapor were moving from the gravel layer and sand cushion and through the concrete slab. The warming of the slab surface during the day and the high internal humidity in the slab and subgrade created vapor pressures high enough to blister the coating. What caused the apparent overnight disappearance of the moisture in blisters wasn't determined. What is known is that drain tiles and capillary breaks didn't prevent this failure, even though the design approach may have appeared sound when the pool was built.
