Slab Moisture Testing: Is It Always Reliable?

When testing concrete slabs for moisture emission before installing impermeable floor toppings, be aware that various environmental and construction factors can affect test results

BY ERIC H. LIDHOLM

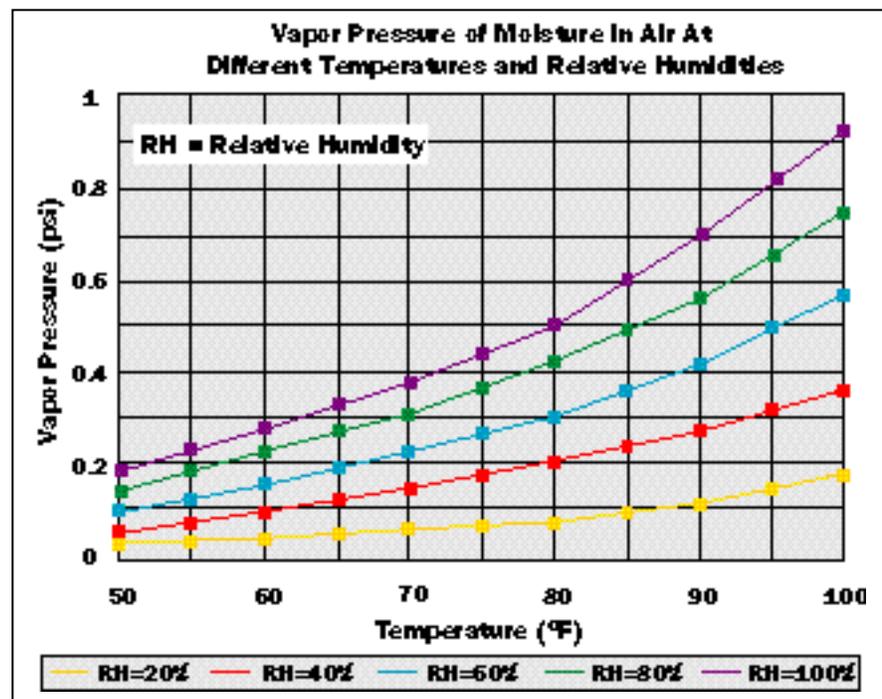
Figure 1. The driving force for moisture movement through a slab is the differential in vapor pressure between the above-slab and below-slab environments. Use this graph to determine the vapor pressure of moisture in air at different temperatures and relative humidities.

An article on avoiding and repairing slab moisture problems provided the answer (Ref. 2). The article describes the driving force for moisture movement through a slab as the differential in vapor pressure between the above- and below-slab environments. Figure 1 shows the vapor pressure of moisture in air at different temperatures and relative humidities.

According to Figure 1, a temperature of 91°F with a relative humidity of 60% indicates an above-slab air-vapor pressure of 0.44 psi. The under-slab temperature at the time of the mat test was estimated to be about 75°F with a relative humidity of about 100%, which also results in a vapor pressure of 0.44 psi. Because little or no differential in pressure existed between the two environments, no vapor transmission occurred. This resulted in a favorable slab moisture-emission test, indicating that the epoxy-terrazzo topping *could* be installed.

After the building's air conditioner was turned on seven weeks later, the interior temperature dropped below 80°F while the relative humidity remained at about 60%. The resulting above-slab vapor pressure was then estimated at 0.27 psi. The climate-control system, therefore, caused a vapor-pressure differential between the above- and below-slab environments of about 0.17 psi. Because pressure differentials are balanced by migration from a high-pressure environment to a low-pressure environment, the moist underslab air migrated to the above-slab environment. This moist air-vapor migration transmitted the damage-causing moisture. More than a year after climate-control of the building interior, the vapor pressure differential is still greater than 0.1 psi.

- Perform slab moisture-emission tests only when the environmental conditions closely approximate the anticipated in-service conditions. In this case, the slab moisture-emission test performed by the flooring contractor indicated dry conditions; however, it is unlikely that dry conditions would have existed had the building been climate-controlled and the resulting difference in vapor pressure existed.

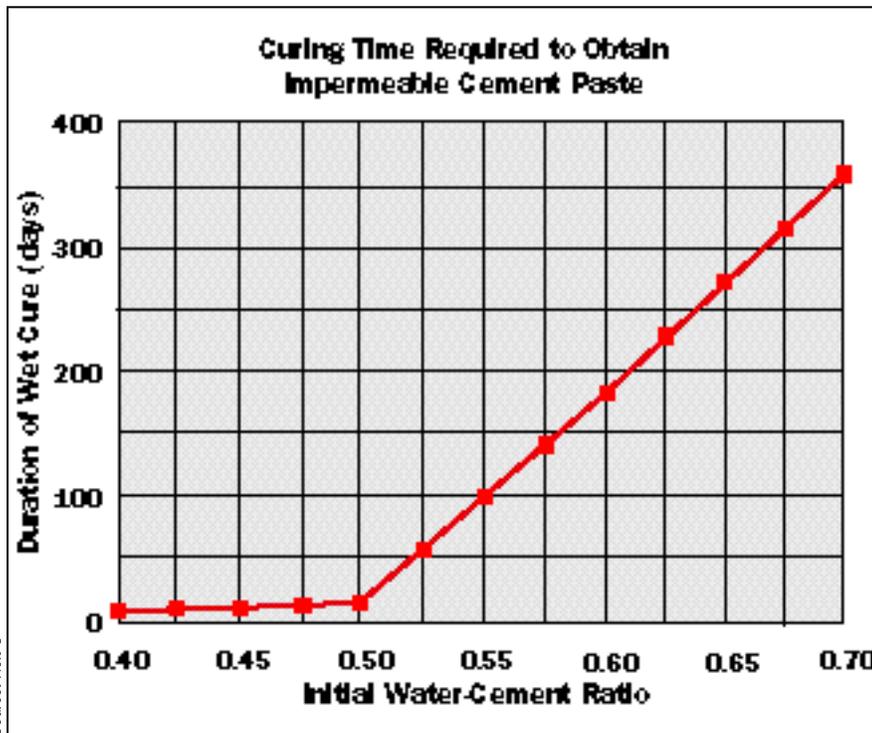
Figure 2. Concrete mixes with water-cement ratios of greater than 0.50 require longer wet-curing times to obtain a relatively impermeable paste. To avoid moisture problems in slabs on grade, try to use low water-cement ratio mixes and provide adequate curing.

Compounding the problem is the slab's relatively high water-cement ratio, which was indicated in the petrographic analysis. As Figure 2 shows, significant wet-curing time is needed to obtain a relatively impermeable paste for concrete mixes with water-cement ratios of 0.51 to 0.57 (Ref. 3). Approximately 25 to 135 days of curing is required to obtain a relatively impermeable cement paste. Unfortunately, the con-

- Use low water-cement ratio mixes for slabs on grade, since these mixes tend to develop a more impermeable paste.
- Adequately cure slabs on grade, maintaining near-optimum conditions, if possible, to help facilitate the development of a more impermeable cement paste.
- Where impermeable flooring materials are to be used, placing the concrete directly on a vapor barrier appears to be the best method for minimizing moisture transmission.
- Minimize the use of an irrigation system adjacent to a structure having a slab on grade underlaid by a granular layer.
- Repair any damage to a vapor barrier prior to placing the granular layer or concrete. 🏗️
